Inspection Report

Property Address:
123 Any Street
Green Valley, AZ 85614

Integri-Spect, LLC Home Inspections

Date: 1/1/2008	Time: 9:00:52 AM	Report ID: sample021808
Property: 123 Any Street Green Valley, AZ 85614	Customer: Sample Inspection Report	Real Estate Professional:

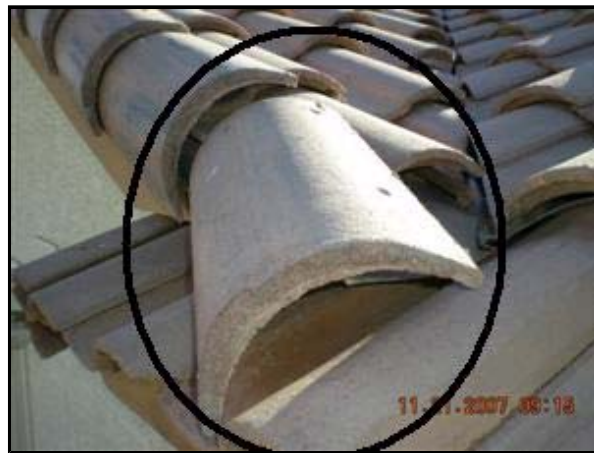
1.0 Picture 1

(4) The rake tile at north east gable end was installed improperly.(Picture 1) It is not fastened to roof or underlying fascia. It should be properly repaired or replaced. A qualified contractor should inspect and repair as needed.

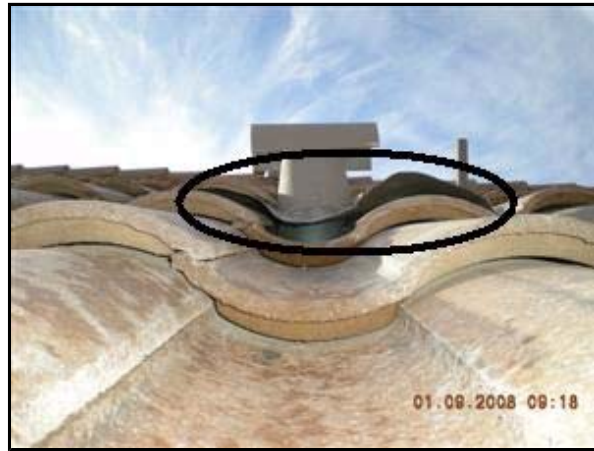
1.4 Picture 1

(2) The flashing is not contoured adequately at the roof for the utility room (north) vent.(Picture 1) This area can leak during wind-driven rain if not corrected. A qualified roofing contractor should inspect further and correct as needed.

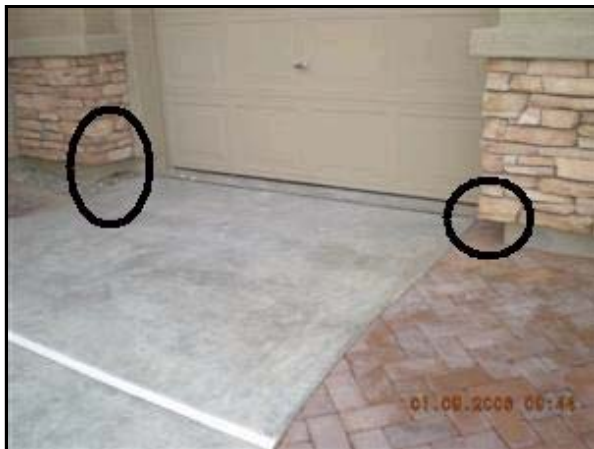
2.0 Picture 1

- 🏠 (2) There is a gap between the stucco weep screed and the concrete foundation (Picture 1) front of home to either side of golf cart garage (Picture 2) which exposes unfinished wood. It is recommended to seal the gap between the weep screed and the foundation, use a low expansion spray foam and then caulk the weep screed to the foundation wall.

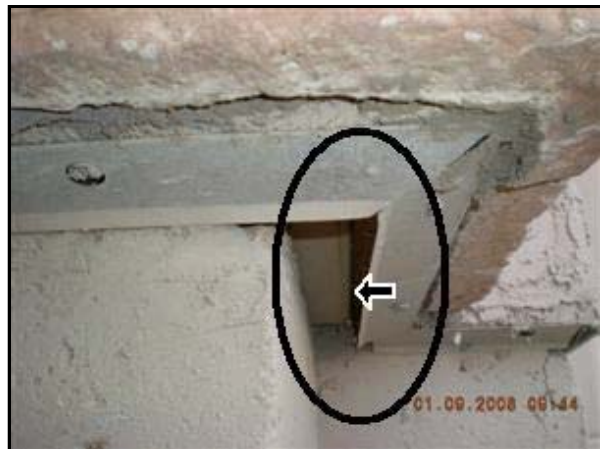
2.0 Picture 2 wood exposed beneath stucco weep screed.

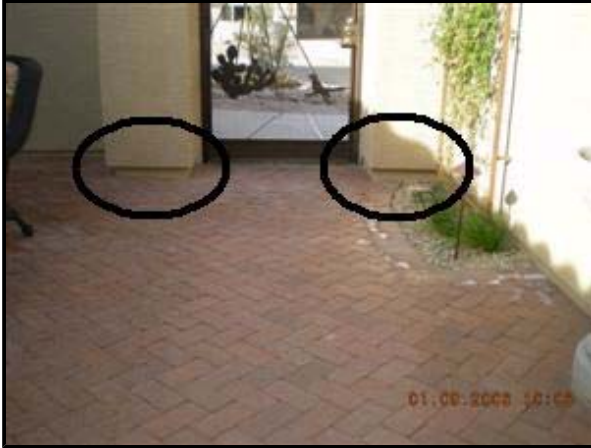
2.0 Picture 3

- 🏠 (3) There is a gap between the stucco weep screed and the concrete foundation(Picture 3) front of home at back side of entry columns (Picture 4) which exposes unfinished wood. It is recommended to seal the gap

between the weep screed and the foundation, use a low expansion spray foam and then caulk the weep screed to the foundation wall.

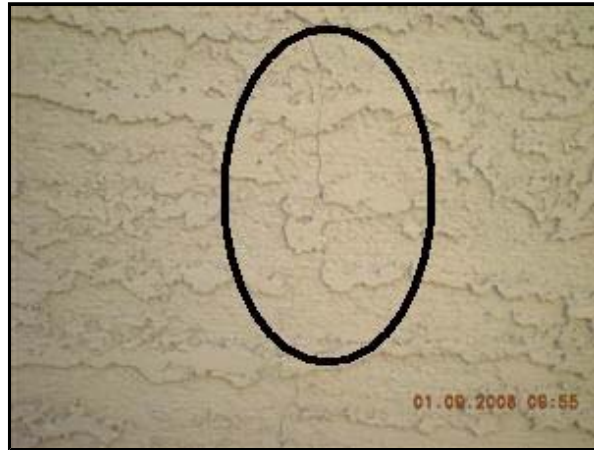
2.0 Picture 5

(4) There is typical hairline cracking in the stucco cladding. (Picture 5) These hairline cracks should be sealed with an elastomeric paint and then painted to match exterior. This is a maintenance issue for your information.

- 🏠 (4) There is typical hairline cracking in the stucco cladding. (Picture 5) These hairline cracks should be sealed with an elastomeric paint and then painted to match exterior. This is a maintenance issue for your information.

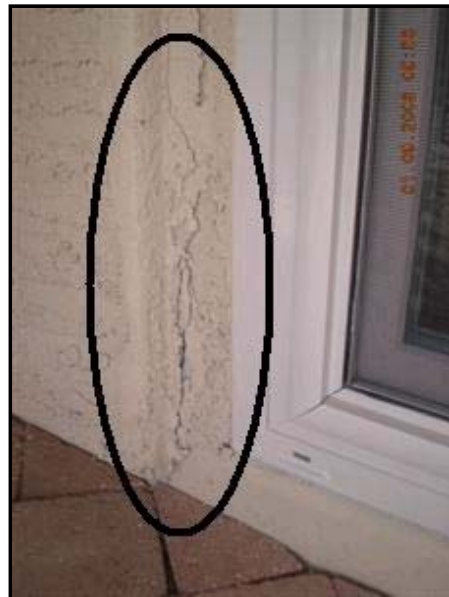
2.0 Picture 6

(5) The Stucco coating at the exterior rear of home to left side of sliding glass door is beginning to deteriorate.(Picture 6) Further deterioration can occur if not corrected. A qualified contractor should inspect and repair as needed.

- 🏠 (5) The Stucco coating at the exterior rear of home to left side of sliding glass door is beginning to deteriorate. (Picture 6) Further deterioration can occur if not corrected. A qualified contractor should inspect and repair as needed.

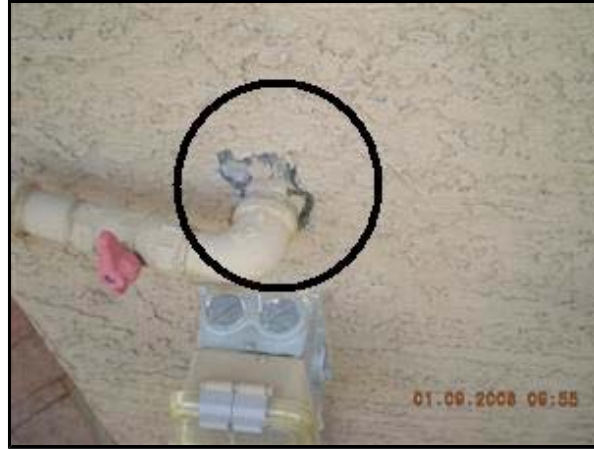
2.0 Picture 7

(6) The Stucco coating at the gas line pipe penetration is deteriorated. Further deterioration can occur if not corrected. A qualified contractor should inspect and repair as needed.(Picture 7)

- 🏠 (6) The Stucco coating at the gas line pipe penetration is deteriorated. Further deterioration can occur if not corrected. A qualified contractor should inspect and repair as needed.(Picture 7)

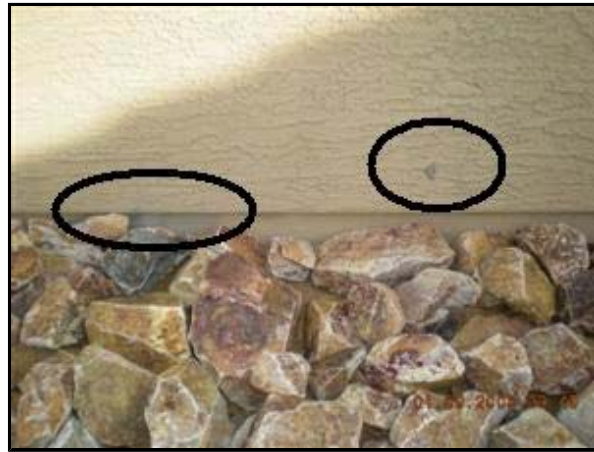
2.0 Picture 8

(7) The Stucco coating at the exterior (North side of home) is damaged and deteriorated. (Picture 8) Further deterioration can occur if not corrected. A qualified contractor should inspect and repair as needed.

- 🏠 (7) The Stucco coating at the exterior (North side of home) is damaged and deteriorated. (Picture 8) Further deterioration can occur if not corrected. A qualified contractor should inspect and repair as needed.

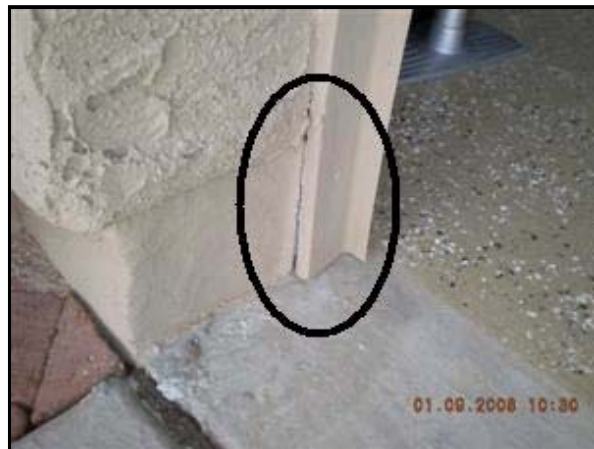
2.0 Picture 9

(8) The door trim casing is loose at main garage door, and golf cart garage doors.(Picture 9) It is recommended to securely fasten casing and caulk as necessary. Further deterioration can occur if not corrected. A qualified person should repair or replace as needed.

- 🏠 (8) The door trim casing is loose at main garage door, and golf cart garage doors.(Picture 9) It is recommended to securely fasten casing and caulk as necessary. Further deterioration can occur if not corrected. A qualified person should repair or replace as needed.

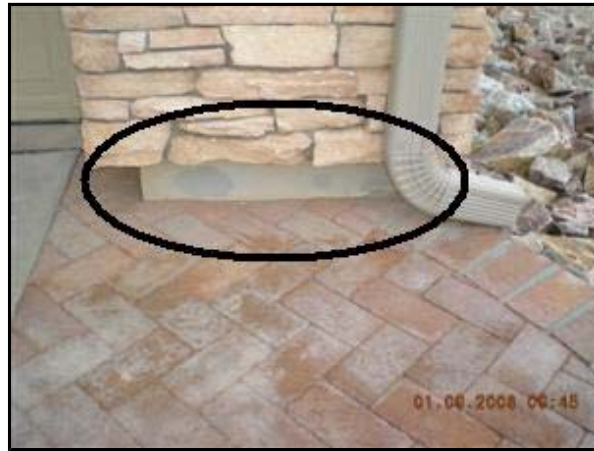
2.0 Picture 10

(9) The foundation to right side of golf cart garage door is not painted. (Picture 10) This is for your information. A qualified person should repair or replace as needed.

- 🏠 (9) The foundation to right side of golf cart garage door is not painted. (Picture 10) This is for your information. A qualified person should repair or replace as needed.

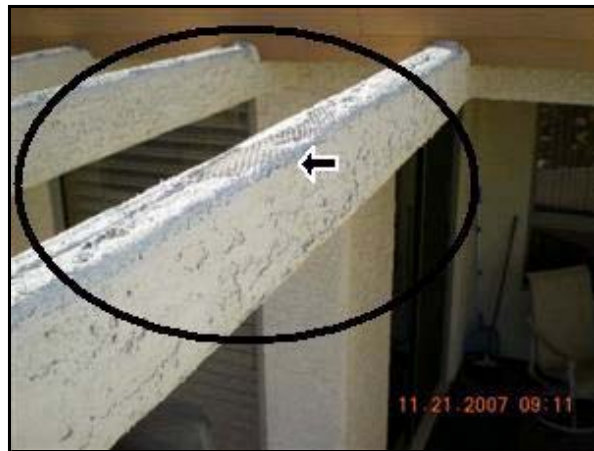
2.0 Picture 11

(10) The ramada at rear of house has unfinished stucco at top surfaces which was installed improperly or not according to standard workmanlike practices.(Picture 11) Further deterioration can occur if not corrected. A qualified contractor should inspect and repair as needed.

- 🏠 (10) The ramada at rear of house has unfinished stucco at top surfaces which was installed improperly or not according to standard workmanlike practices.(Picture 11) Further deterioration can occur if not corrected. A qualified contractor should inspect and repair as needed.

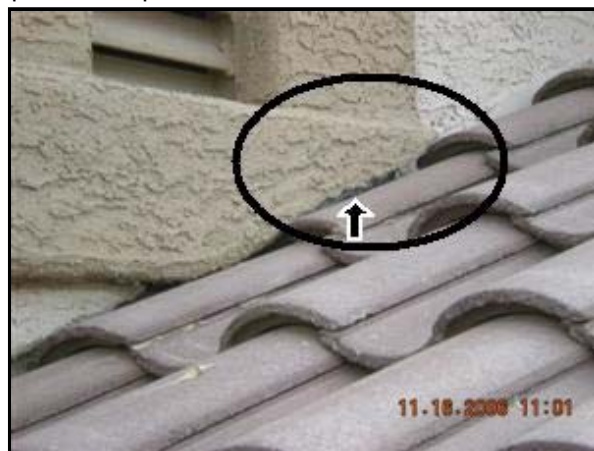
2.0 Picture 12

(11) The Stucco coating at the exterior front of home (under window cornice above garage roof) is unfinished and deteriorated along bottom edge.(Picture 12) Deterioration can eventually occur if not corrected. A qualified contractor should inspect and repair as needed.

- 🏠 (11) The Stucco coating at the exterior front of home (under window cornice above garage roof) is unfinished and deteriorated along bottom edge.(Picture 12) Deterioration can eventually occur if not corrected. A qualified contractor should inspect and repair as needed.

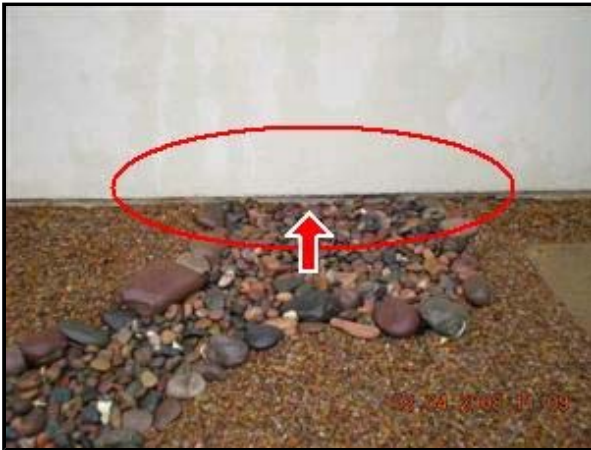
(2) There is a negative slope towards the (East side of home). (Picture 1) (Picture 2) This area does not appear to drain water away from home and needs landscaping and drainage corrected.

2.4 Picture 1 signs of water intrusion

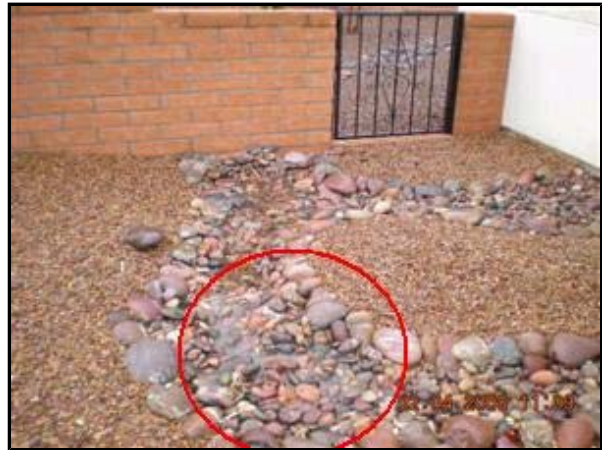
2.4 Picture 2 water ponding present

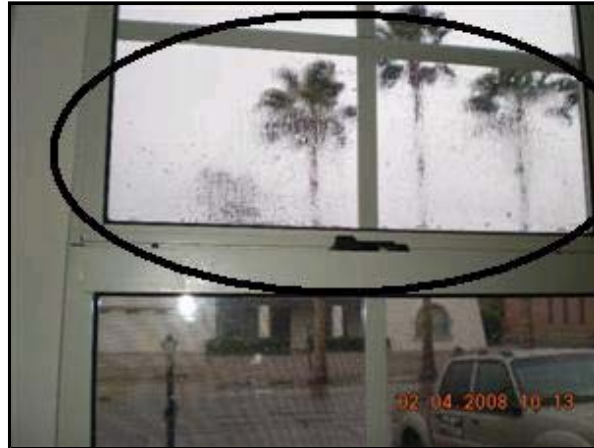
4.5 Picture 1

(4) The window sills in casita have signs of moisture.(Picture 1) (Picture 2) It is recommended to check window Weatherstripping to assure tight fit, and repair/repaint sills. Further deterioration may occur if not repaired. A qualified contractor should inspect and repair as needed.

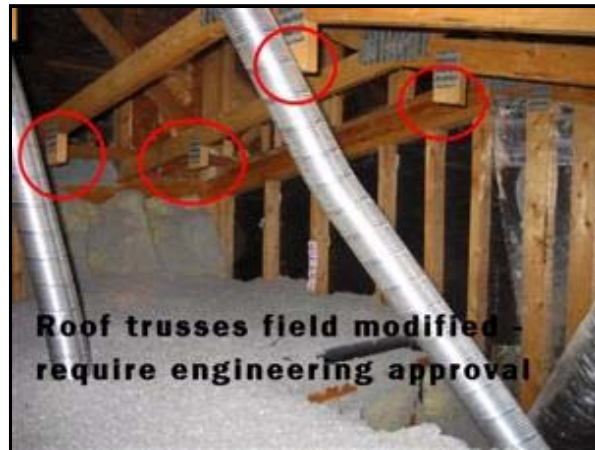
5.4 Picture 1

(2) The 2x4 trusses have significant field modifications above Master bedroom. (Picture 1) The roof trusses need repair. Truss repairs should be approved by an engineer or qualified architect before performing the work involved.

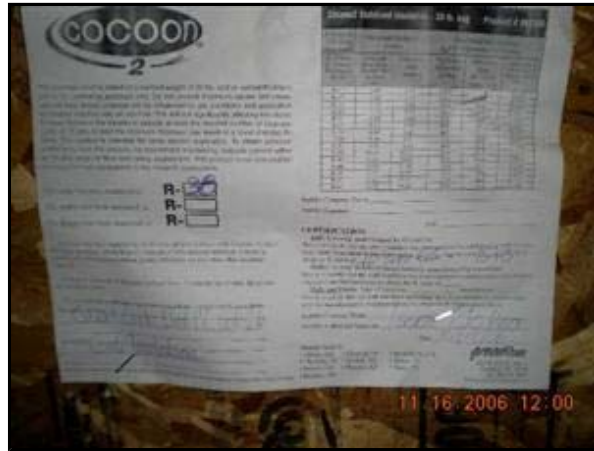
6.0 Picture 1

(1) Cellulose insulation is certified (Picture 1) to be about ten inches thick or just over 36.6 R-Value.

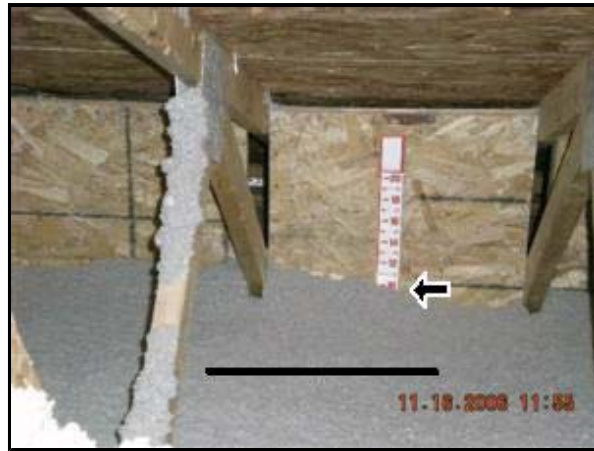
(3) The insulation above the master bedroom is not the required 10 inches. The insulation has been shoveled against the rule to appear as 10 inches. (Picture 1) It is recommended that a qualified insulation contractor provide additional insulation to certified standards.

- 🏠 (3) The insulation above the master bedroom is not the required 10 inches. The insulation has been shoved against the rule to appear as 10 inches. (Picture 1) It is recommended that a qualified insulation contractor provide additional insulation to certified standards.

6.0 Picture 2 line is insulation level; arrow is shoved insulation.

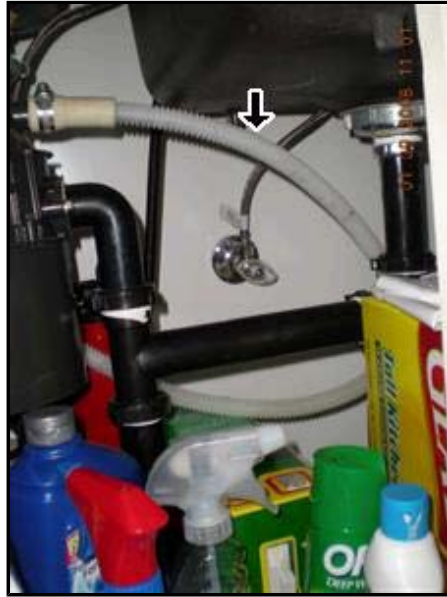
8.0 Picture 1

(2) The dishwasher drain needs to have a high loop or air gap installed.(Picture 1) I recommend repair as necessary.

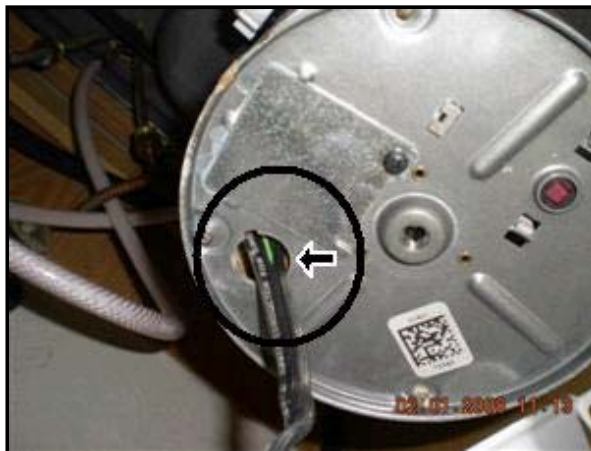
8.3 Picture 1

The food disposer wiring is missing a romex connector (anti-strain device). I recommend repair as needed.

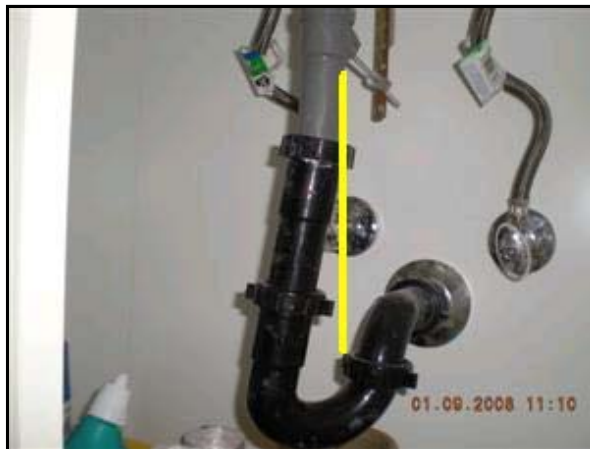
9.0 Picture 1

(4) One of the master bathroom sinks (west) has a tail piece misaligned to 'P' trap. (Picture 1) This is not considered up to today's standard. A qualified licensed plumber should repair or correct as needed.

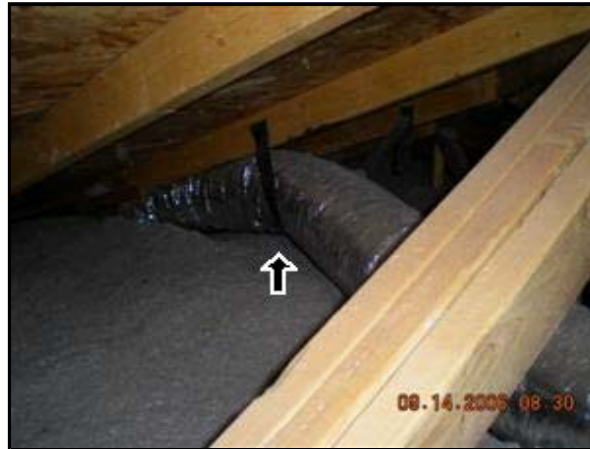
11.3 Picture 1

(2) The supply duct to master bathroom is choked by the support straps in the attic (Picture 1) contributing to inadequate air flow. A licensed HVAC contractor should service or repair unit.
